A Hydrologic Study of the Macatawa River Watershed

Executive Summary

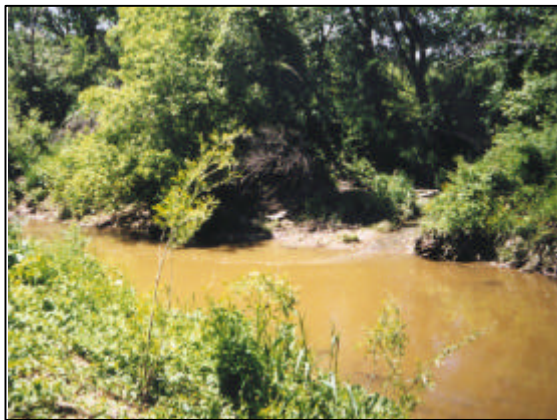
Photo A. Tributary entering the Macatawa River just possible west of 84th Street

Field inspection of the three subbasins was conducted to find a location for a proposed flood control structure. The goal is to find a location that was situated along the Macatawa River with a drainage area large enough to significantly impact the peak downstream. For example, a drainage area of five square miles contributes such a small percentage of the Macatawa's total runoff volume, that retention of this runoff would have little effect on the flood crest. It is also important that the site chosen for a flood structure be publicly or governmentally controlled by means of ownership or easement rights. The County Road Commission property along the Macatawa River at 84th Street in Zeeland Township appears to be the site with the greatest potential for this purpose. (See Figure 5, Photos A and B, as well as plat map information in Figure 6.)

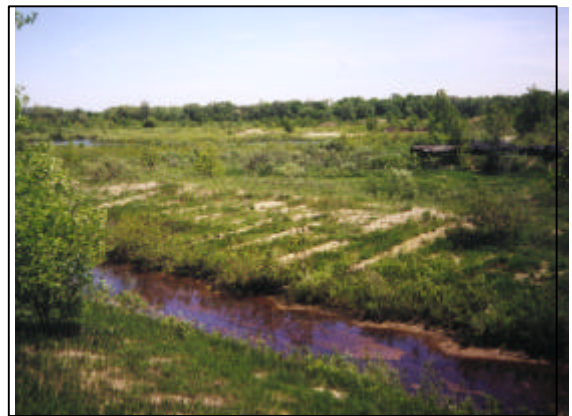
Photo B. Ottawa County property and location for a flood storage area

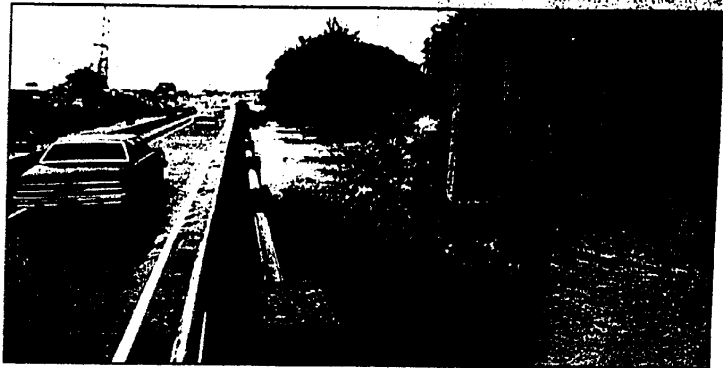
RISEING: The Black River passes inches below bridge on Chicago Drive Saturday. A work crew scrambled to shore up the repairs and move back equipment that could be swept away by the rising waters.
